Ms. Jessica Ward and for her account, the undersigned marine surveyor conducted a PrePurchase, Condition, Valuation, and Suitability for Service Survey, on June 1st, 2022 on the *M/V Belafonte* while the vessel was afloat at Cape Fear Marina, hauled ashore for inspection at Off the Hook Yacht Services, and while underway along the Cape Fear River, Wilmington, North Carolina.

Jim Bussmann
Bussmann Marine Surveying

| Year/Make/Model | : 1985, Monk, Seahorse 36 Trawler |

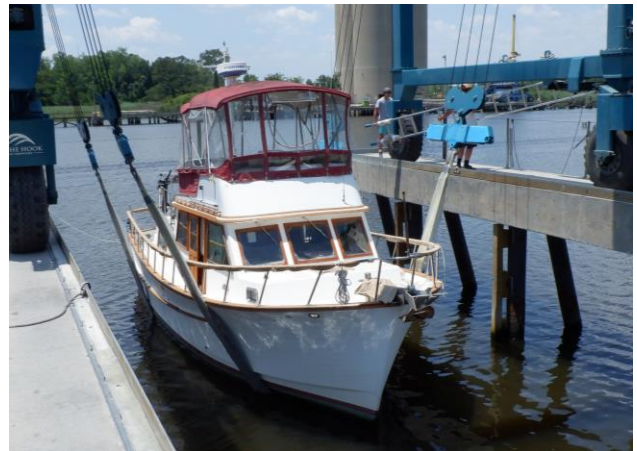
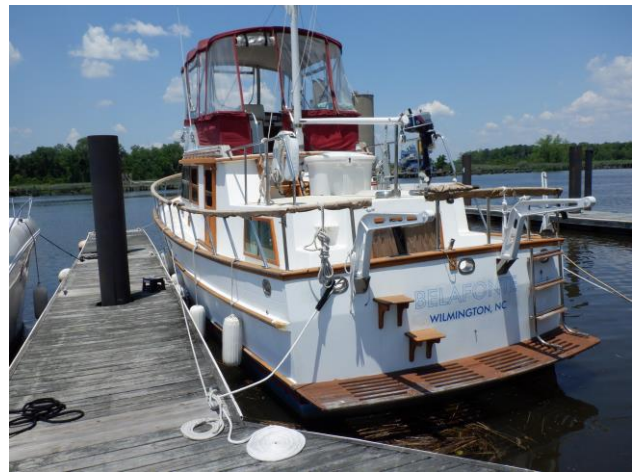
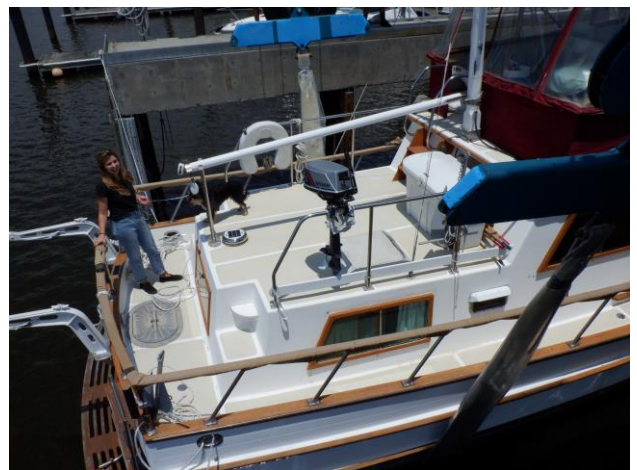
The hull is of solid hand laid fiberglass construction from a female mold utilizing woven roving, stranded mat and polyester resin throughout. The semi displacement hull underbody showing 3/4 length keel, single spade rudder, and hard chines. The hull is reinforced by a framework of longitudinal and transverse corded stringers, main engine bedlogs, structural bulkheads and interior joinery, all of which is bonded to hull. Where inspected all tape and attachment points appear good with no obvious separation or tearing from hull noted. The port and starboard stringers starting just forward of the engine room appear to have coring that has deteriorated due to moisture intrusion, a possible cause for the starboard side stringers core deterioration is a limber hole being drilled through the bottom of the stringer to allow a hose to pass through and not being sealed properly, how far forward the deterioration extends was not determined due to access, a qualified laminate technician should be engage to evaluated the extent of the

deterioration and make recommendations for possible repair. The hull topsides are the original white gelcoat finish with red boot stripe, and blue bottom. Teak rub rails are provided at shear with stainless steel striker. Wooden lower rubrail extends from midship thru to stern with stainless steel striker. Transom is fitted with a teak swim platform with retractable stainless steel reboarding ladder. Platform is supported by (4) four substantial stainless steel brackets, through bolted to transom.

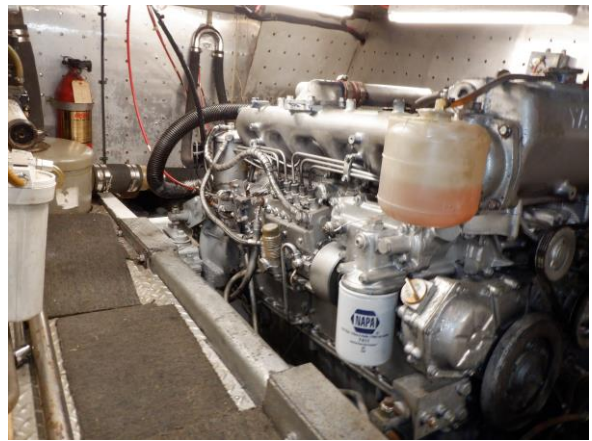
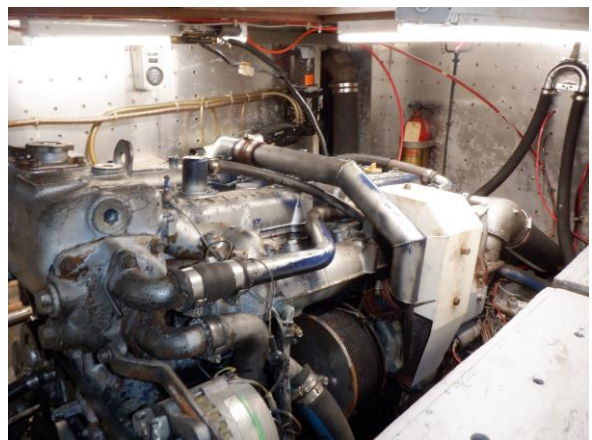
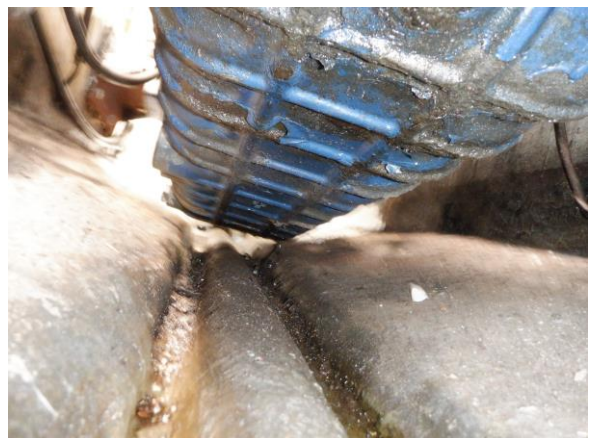
The vessels propulsion machinery is based on a single Yanmar model 6PHM-TE, inline six cylinder, turbo charged, fresh water cooled diesel engine rated at 145 horsepower @2800 RPMs, serial number 190299132. Engine drives via Borg Warner Velvet Drive marine transmissions with reduction gears, rated at 2.0:1, coupled to 1-3/4 inch stainless steel shaft. Prop shaft exit hull via standard flange bolt flax packing stuffing box, connected to bronze shaft log. Shaft is supported under water by bronze stern tube with water lubricated cutlass bearing and a "P" strut with a water lubricated cutlass bearing. Shafts turn 3 blade 22" (estimated) bronze propeller. All couplings were found to be secured and packing gland assembly was in good order as were cutlass bearings.

The main engine is set upon resilient adjustable mounts that are in turn lag bolted upon longitudinal engine beds. Engine is 12 volt DC electric started. Fresh water cooled via engine mounted heat exchanger and having wet exhaust with water injected elbow. Exhaust exits at transom via approved hose and composite aqua-lift muffler in the engine compartment. Attached units include (1) one each, seawater circulating pump and 12VDC

8. Have a qualified engine mechanic do a full evaluation of the main engine, transmission and the generator, and make recommendations for service and repair.

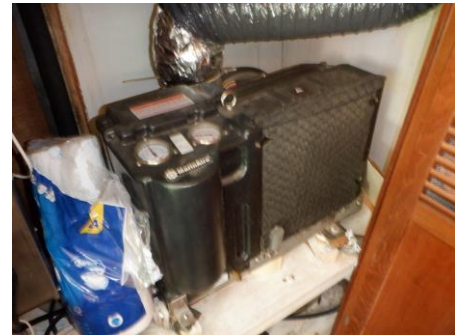
The vessel is equipped with a two recent 16,000 BTU Marine Aire reverse cycle air conditioning units, with electronic thermostat control. Raw water intake lines are fitted with basket

strainers and separate circulating pumps. The forward unit showed 56 degree output air, the aft unit initially had difficulty starting properly and showed 67 degree output air with 105 degree input air. A Webesto diesel heater is installed starboard side outboard in the engine compartment, the unit was reported to be inoperative at the time of the survey, a qualified technician should be engaged to examine the unit for service/repair before any attempted use.

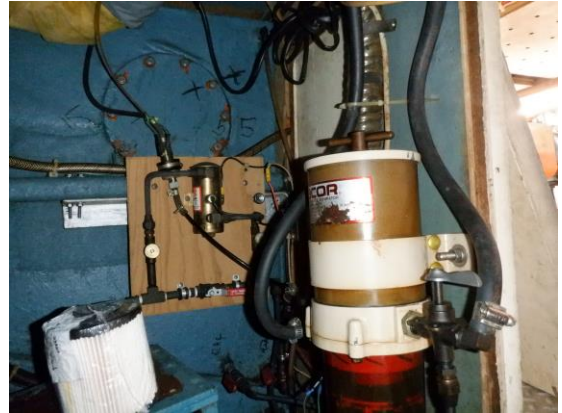
Diesel fuel is stored in two, what appear to be original, welded mild steel tanks located outboard port and starboard in engine compartment. Each tank with separate deck fill at weather deck and vents at hull sides. Due to attached insulation only a very limited visual inspection was possible. Tanks appear to be

covered in fiberglass, chopped mat, and painted with blue enamel. Large cleanout/ inspection ports are fitted at each tank, no leaks or fuel smells where detected. Tanks appear well secured. Fuel is supplied through approved type hose, through selector/shut off valves to Racor model 900 FG fuel water separator filter and small secondary Racor filter. A 12VDC filter priming pump is also installed. Visible components and installations

were accessible appear to be in good serviceable condition. ***Due to the type of material of the tanks and their age the buyer should be prepared for tank replacement sometime in the future which is very common/typical for this type and age of tank.*

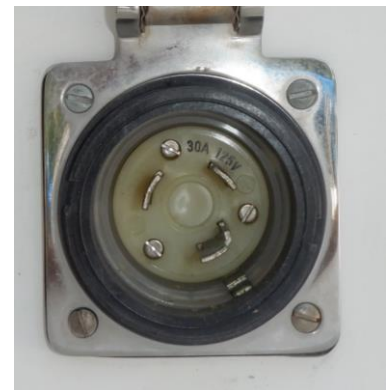
The 12 volt system is supplemented by a single 30 amp shore side system via approved type 30 amp shore power cord and inlet fitting, no evidence of overheating was evident at the cord ends or inlet fitting. A Xantrex automatic marine battery charger starboard side forward in the engine compartment and an engine driven alternator.

Distribution panel fitted with single pole main breaker, polarity indicator, analog voltage meter, and subcircuit thermal breakers. *The 120 volt distribution panel is equipped with 50 amp main breaker and should be changed to 30 amp to match installed components.*

9. Carbon Monoxide Detectors and Smoke Detectors are recommended for each living space, install detectors in each cabin and the main saloon.
 10. Main 120VAC breaker is rated at 50 amp, this should be removed and replaced with a 30 amp main breaker to match the shore power cord and inlet fitting. Have a qualified marine electrician evaluate the single shore power system for the demands imposed by the two 16,000 BTU air conditioners and if a second shore power system is needed to meet the power demands.

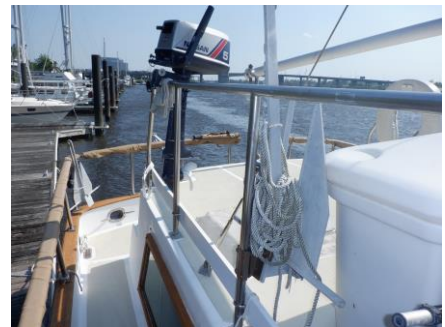
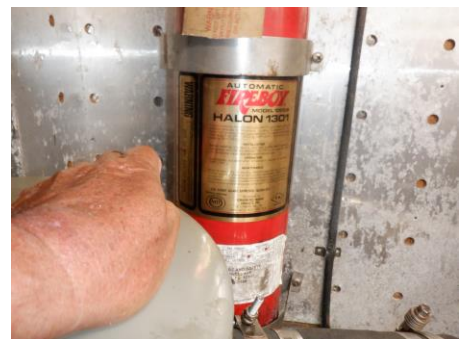
(1) One Fireboy, Model 100CG Halon 1301 automatic fire suppression system in the engine compartment, date of last inspection not known.

**ABYC A-4 and NFPA 302 recommends that fixed fire protection systems be inspected and reweighed at one year intervals and tagged accordingly. Recommend compliance.
