Ms. Jessica Ward and for her account, the undersigned marine surveyor conducted a PrePurchase, Condition, Valuation, and Suitability for Service Survey, on June 1st, 2022 on the *M/V Belafonte* while the vessel was afloat at Cape Fear Marina, hauled ashore for inspection at Off the Hook Yacht Services, and while underway along the Cape Fear River, Wilmington, North Carolina.

Jim Bussmann
Bussmann Marine Surveying

| Year/Make/Model | : 1985, Monk, Seahorse 36 Trawler |

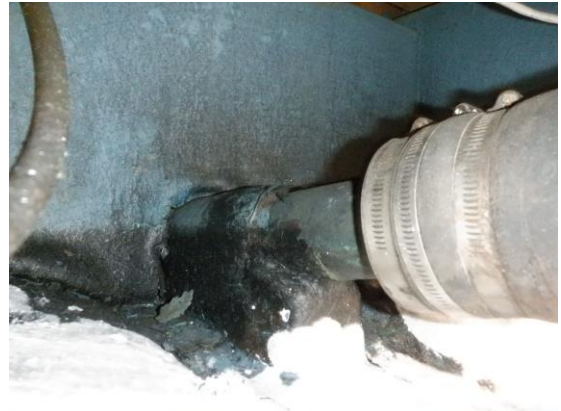
Engine room ventilation is provided via vents inboard at gunwale. The engine gauge and alarm system consists of gauges and warning lights for revolutions, oil pressure, water temperature, and charge output. Engine is controlled through Morse dual lever controls using push-pull cables, one set each at upper and lower helm. Current metered hours are, 4,538 on recently removed original gauge, new gauge shows 2 hours. Accuracy was not confirmed.

Engine started promptly and ran in forward and reverse gear at various speeds, without any abnormal indications, the gear shift engaged smoothly, throttle and gear shift function was normal. The engine was run to full throttle and achieved 2,250+ RPM's under load, (the no load WOT was 2,500 RPMs), below rated RPMs, no excessive vibration was felt over the whole speed range. Cooling water and lubricating oil pressures were normal and remained constant within the speed range, the vessel tracked well without excessive adjustments of the helm, Steering response was good. No leaks were observed of cooling water or lubricating oil during or after trial run. There was no diesel mechanic aboard at the time of inspection and only a visual inspection of the engine installation and exterior components was done, no reference or information should be construed to indicate an evaluation of the internal condition of the engines and the propulsion system's operating capacity, which is beyond the scope of this survey.

Complete inspection of machinery, plumbing, electrical systems and equipment could only be made by disassembly or by continuous operation. This has not been done. No mechanical tests were performed on propulsion or auxiliary generating equipment. No compression tests were performed. No fluid samples were drawn. Only the installation and external condition of machinery and ancillary equipment were inspected. A full engine, transmission, and generator evaluation should be conducted by a qualified marine mechanic.

8. Have a qualified engine mechanic do a full evaluation of the main engine, transmission and the generator, and make recommendations for service and repair.

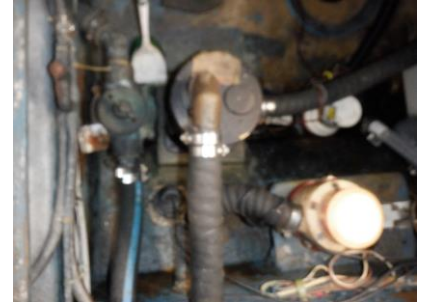
The vessel is equipped two Rule bilge pumps with float switches in engine compartment wired for automatic and manual operation. One- 2000GPH and one 3000GPH.

CAUTION: Bilge pumps are high maintenance items. Bilge pumps are only the initial part of a de-watering system, which may include a strum-box, check-valves or occasionally anti-siphon loops and valves, piping, a seacock if the exit is below waterline and a thru-hull tailpiece. This entire system must be understood and maintained. Bilge pumps may fail at any time. No warranty as to longevity can be expressed or implied at survey. Tapered wooden plugs tied to seacocks are an inexpensive safety item and highly recommended under current ABYC standards. Keeping bilges clean and free of debris is a vital part of insuring proper operation. It is also recommended that each bilge pump be periodically tested by filling the immediate bilge area with water, to ensure the pumps and float switches are operating as designed.

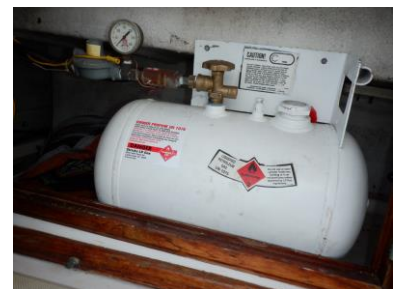
(1) One Majic Chef, 4 burner propane stove top with oven, system fitted with remote solenoid shut off. A leak down test was performed.

The vessel's propane tank is mounted in a locker that opens from the side below the seating on the upper deck. This arrangement was compliant when the vessel was built and upgrading to meet current standards would be prohibitively expensive and would not really do much to enhance the safety of the vessel. A leak down test should be performed regularly.

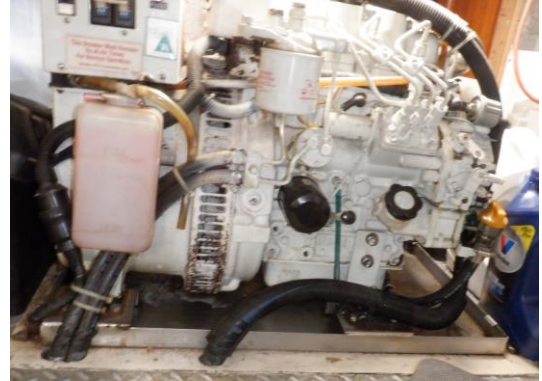
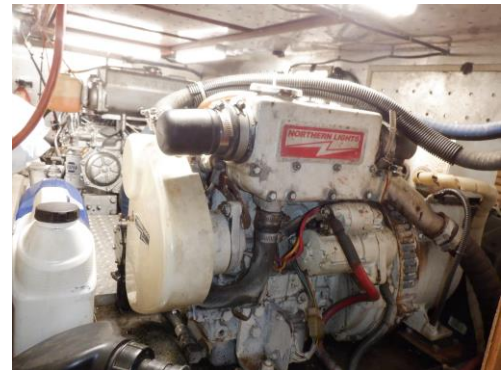
The vessel is fitted with a Northern Lights, 6.5kw., 3 cylinder diesel generator, serial number 190299132 (reported) located forward in the engine compartment. Operational hours are approximately 300, accuracy was not confirmed. Unit is a replacement for the original generator, date of installation not reported. Unit appears to be in generally well maintained condition. Generators fuel feeds via approved hose feeding Racor fuel/water separator filter, engine mounted secondary filters and fuel pump. Installation of hosing and fuel distribution was found to be in good order and in compliance with regulatory standards. The generator's cooling and exhaust system is based on raw water intake through bronze strainer, feeding engine driven raw water pump, engine mounted heat exchanger, then mixing at injection elbow and discharges out hull side via approved type flexible exhaust hose through composite aqualift type muffler, hoses and clamps were in well maintained condition. The generators auto shutdowns were not tested for proper operation. Starting and preheat service is provided at the unit and a remote cabin panel. The unit started easily was run up to operating temperature and tested under moderate load, output was 116 volts @ 61 Hertz.

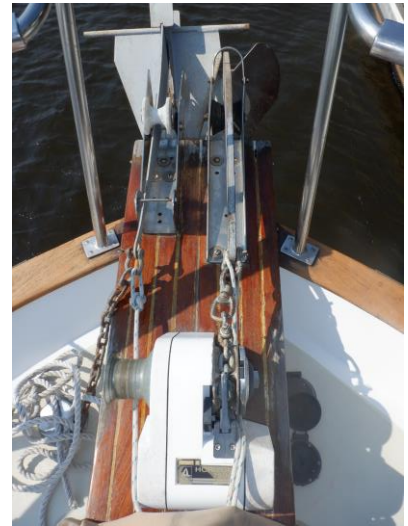
(1) One Simpson Lawrence, Horizon 1500 12VDC electric windlass at bow. With foot switches, helm controls, overcurrent breaker mounted forward in the forward cabin.
